GEOTECHNICAL REPORT

**PRELIMINARY GEOTECHNICAL ASSESSMENT,
7054 HART HIGHWAY, PRINCE GEORGE, B.C.**

**NORTHERN HEALTH AUTHORITY
PRINCE GEORGE, B.C.**

PROJECT No. K-2037

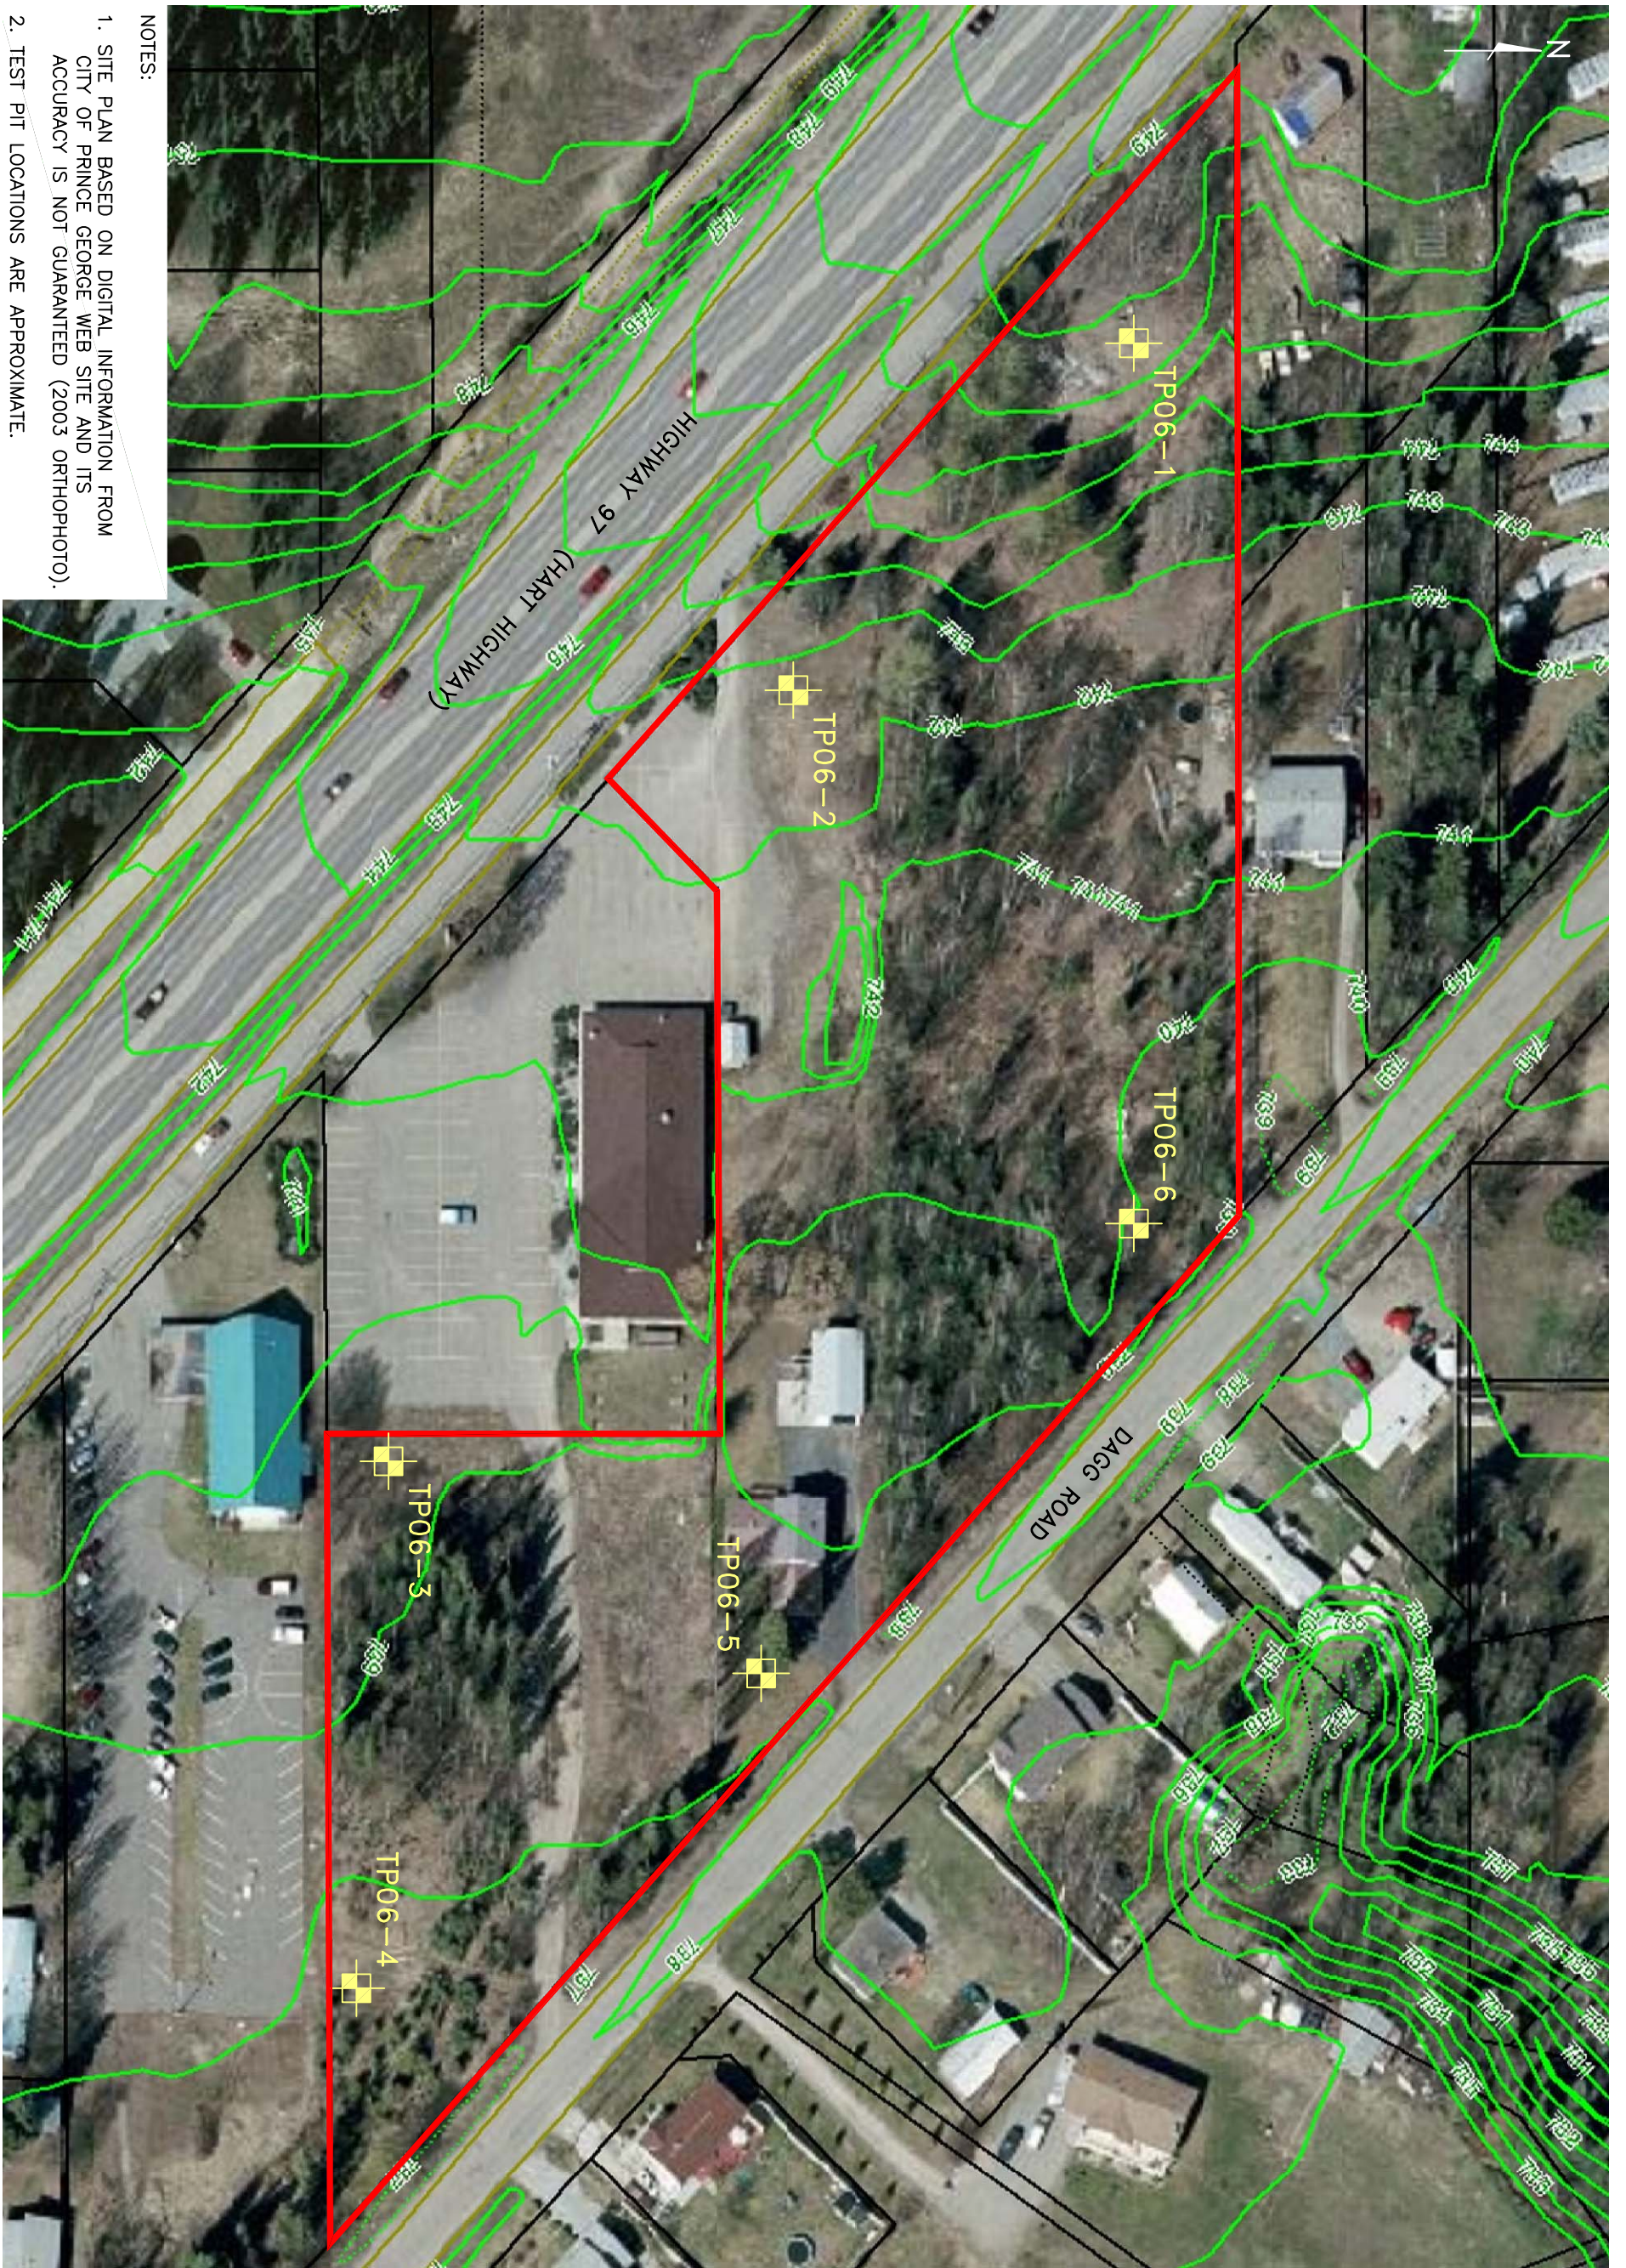
SCALE: 1:1000
 DATE: 2006/05/17
 DWN BY: LU
 MAP REF: -
 DWG NO. 2037-A2

The subject property is located in the Austin East area of Prince George. The property is bounded on the west by the Highway 97 N Frontage Road (Hart Highway), on the east by Dagg Road, on the north by existing residential properties, and on the south by the Hart Pioneer Centre and the Hart Pentecostal Church. The site has an area of approximately 2 hectares. A plan showing the site location is on Drawing 2037-A1, in Appendix A. A plan showing an orthophoto taken in 2003, available on the City of Prince George website, is on Drawing 2037-A2, and a plan showing the site layout is on Drawing 2037-A3, both in Appendix A.

NORTHERN HEALTH AUTHORITY
PRELIMINARY GEOTECHNICAL OVERVIEW ASSESSMENT
 7054 HART HIGHWAY, PRINCE GEORGE, B.C.
SITE PLAN SHOWING TEST PIT LOCATIONS

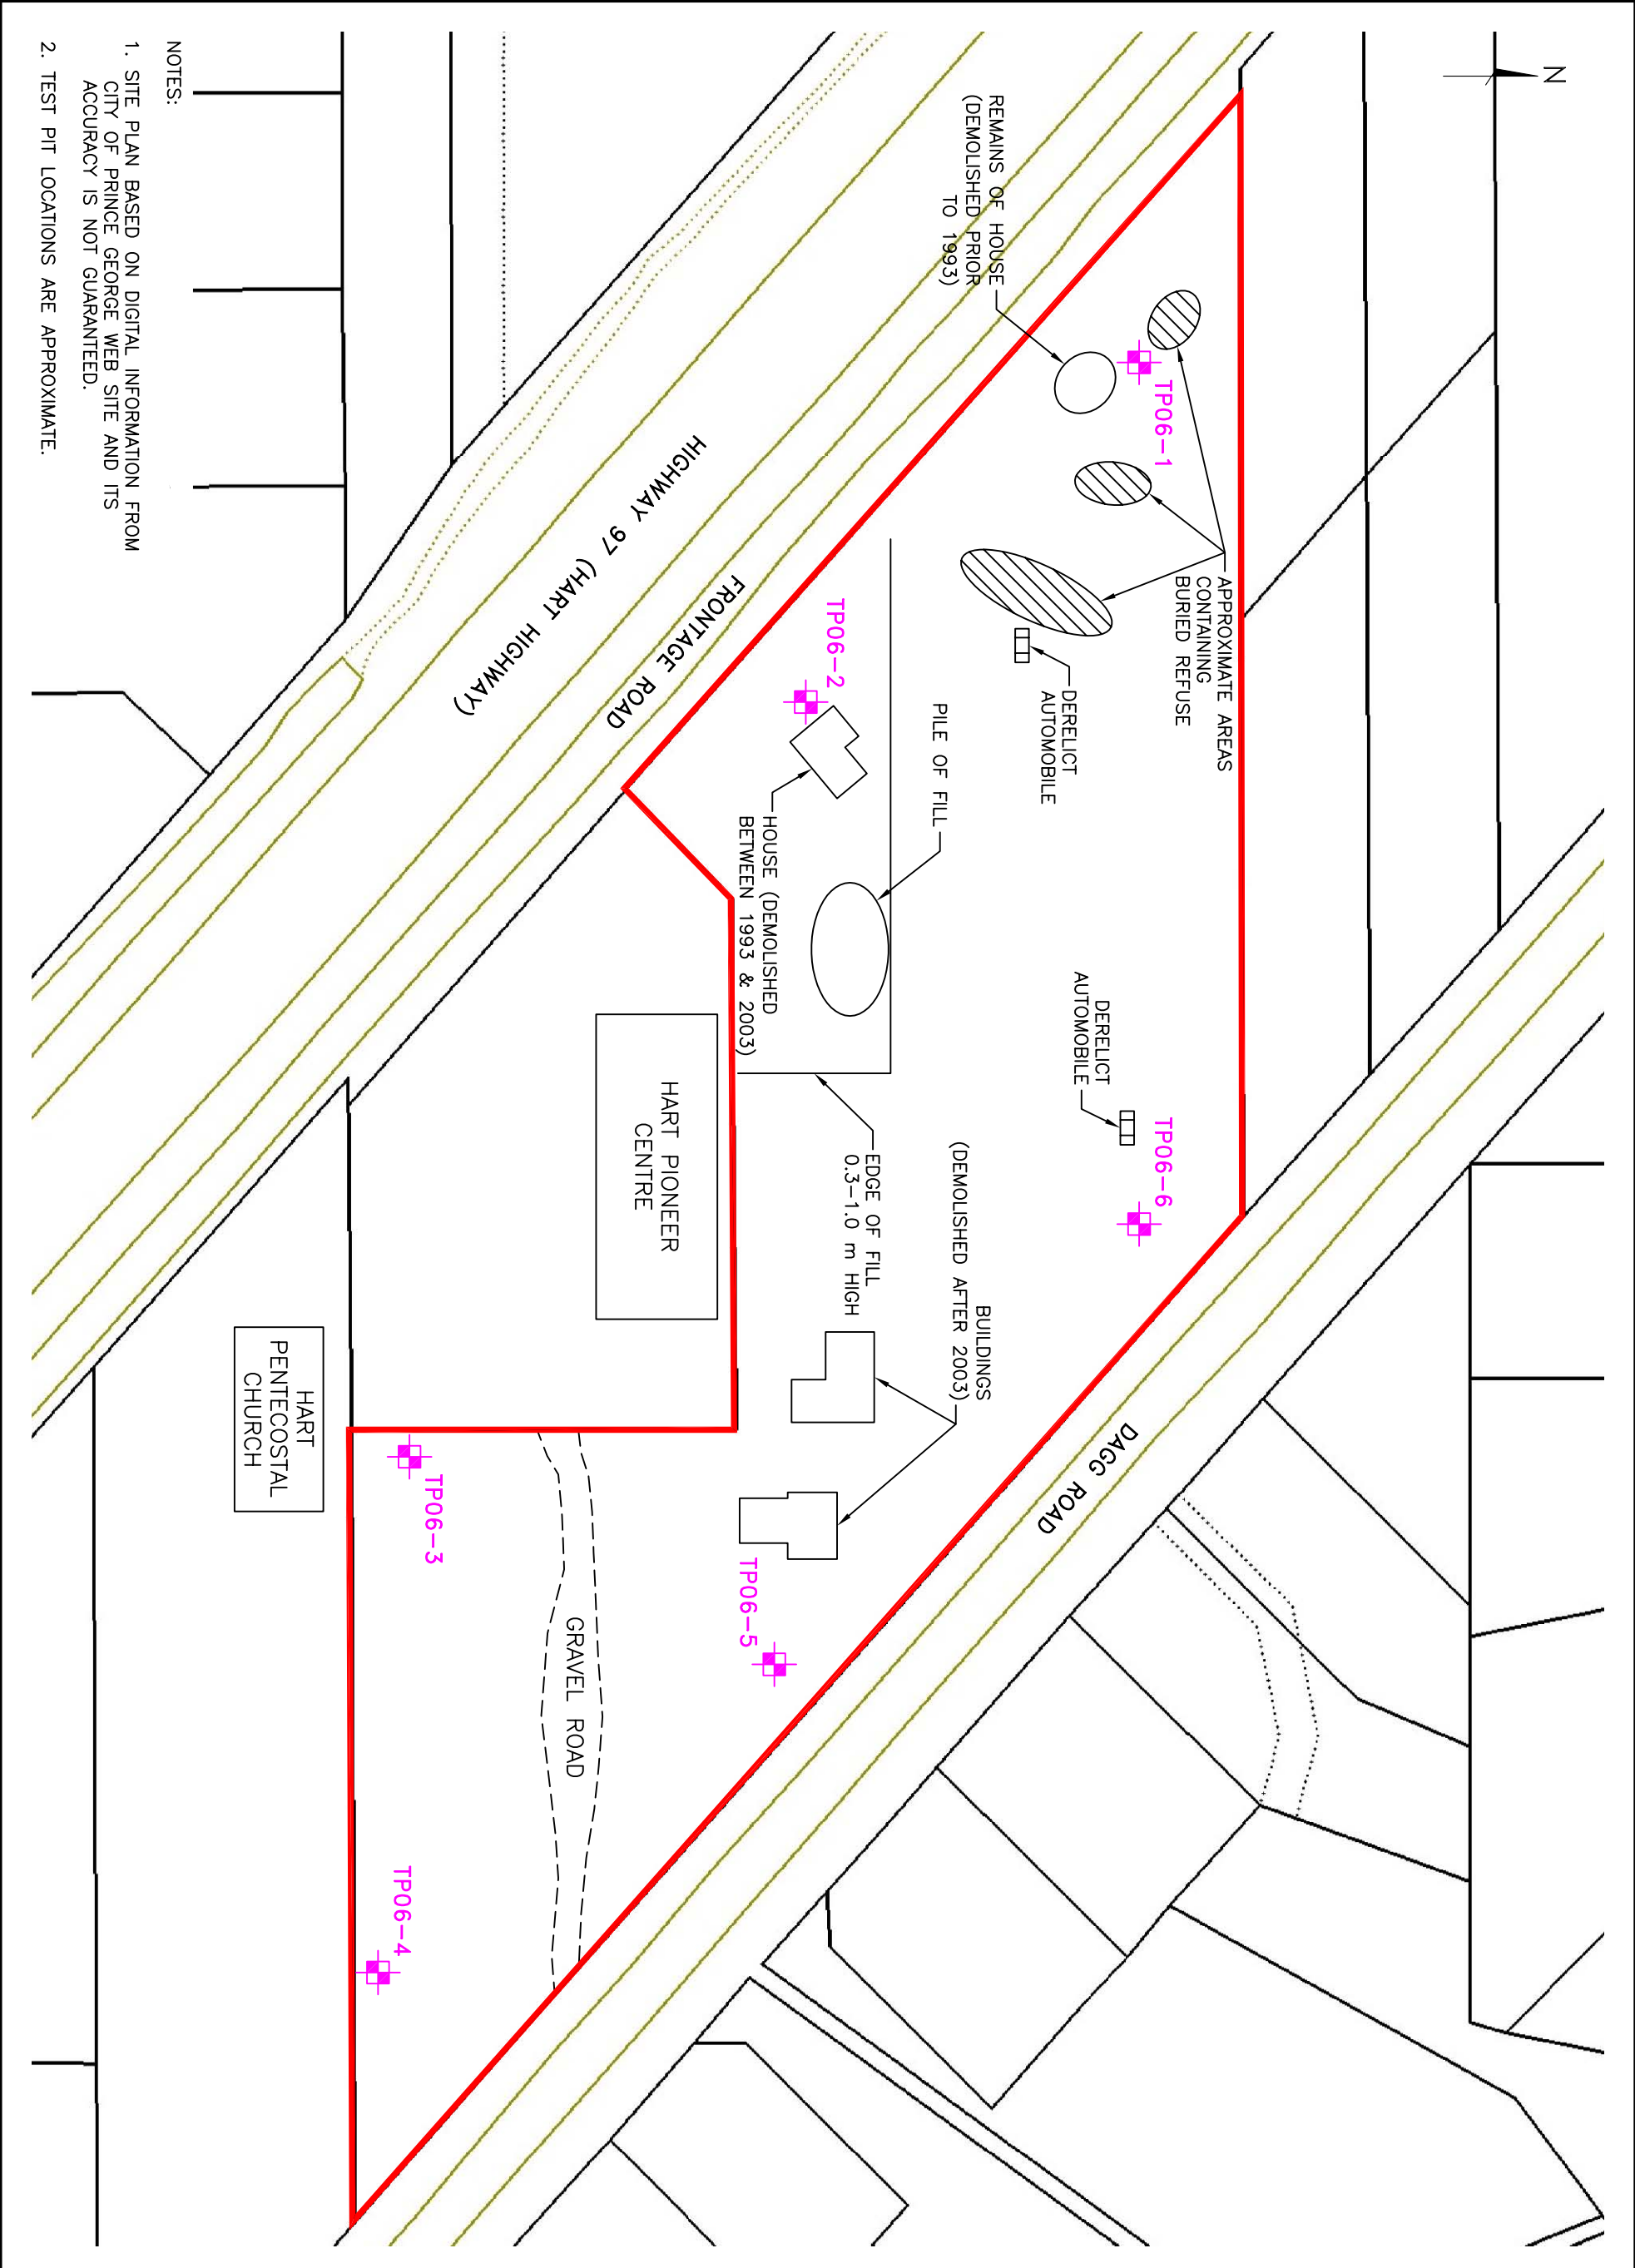
SCALE:	1:1000
DATE:	2006/05/17
DWN BY:	LU
MAP REF:	-
DWG NO.	2037-A3

The site is primarily flat-lying, with a gentle, east-facing slope in the northwest corner, north of the Hart Pioneer Centre. Areas of the property are treed, as shown on Drawing 2037-A2. Along the Highway 97 frontage road, there are indications of variable depths of fill associated with one or more previously existing houses. There is an existing gravel road between the Hart Pioneer Centre parking lot and Dagg Road.

NORTHERN HEALTH AUTHORITY
PRELIMINARY GEOTECHNICAL OVERVIEW ASSESSMENT
7054 HART HIGHWAY, PRINCE GEORGE, B.C.
SITE PLAN

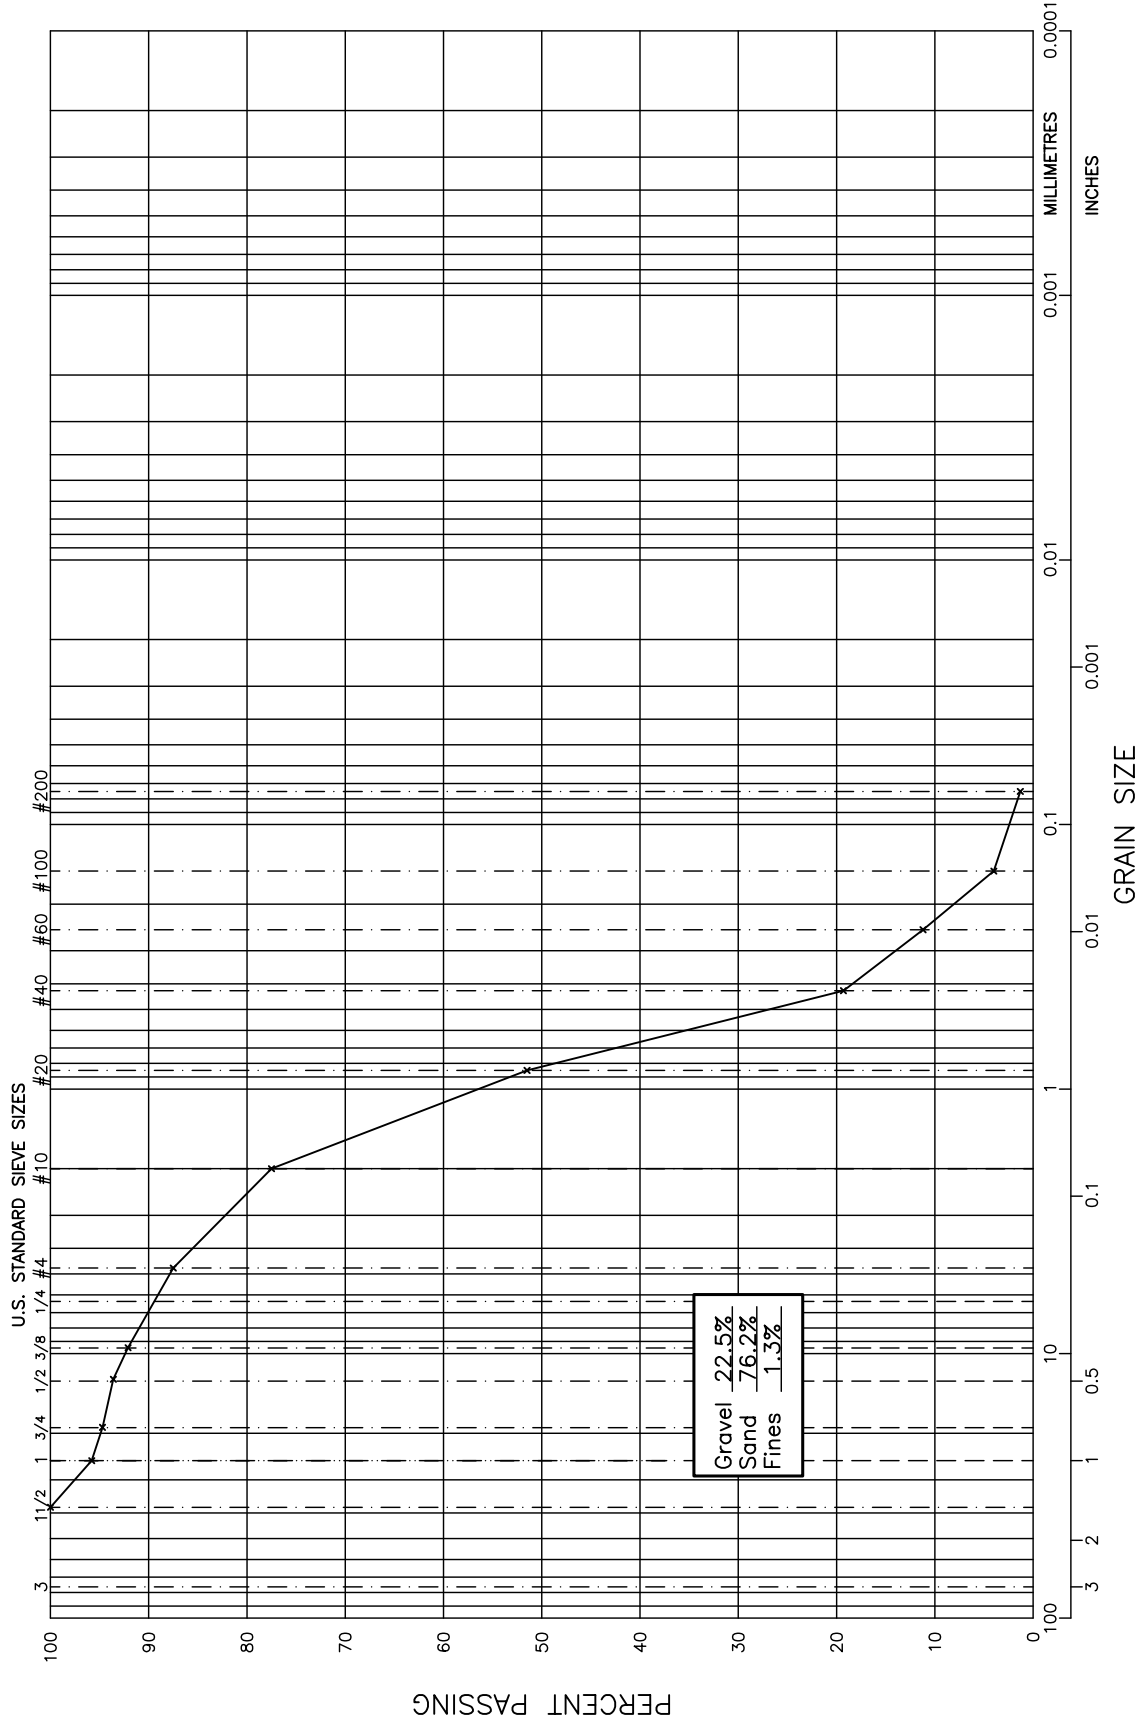
0.3		- thin, organic layer at 0.3 m.		- Grain Size Analysis, See Plate 2037-B4
0.9		SAND, coarse grained, gravelly, fine to medium grained gravel, clean, compact, brown, damp.

Gravel 22.5%
 Sand 76.2%
 Fines 1.3%

Test pit logs describing subsurface conditions are presented on Plates 2037-B1 to B3, in Appendix B. An explanation of the terms and symbols used on the logs is in Appendix C. We carried out laboratory testing on all samples to determine the natural moisture content of the soil. Selected samples were tested to determine their grain size distribution and fines content, that is, the percentage of soil by weight that is smaller than 0.075 mm diameter. The testing results are shown on the test pit logs and on Plate 2037-B4, also in Appendix B.

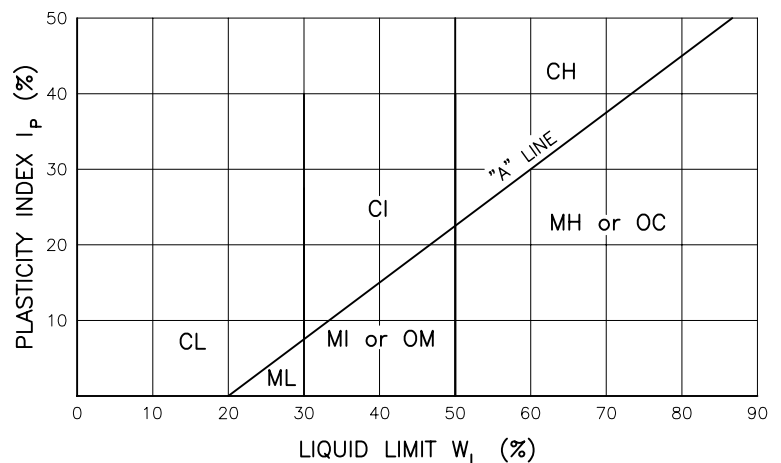
PLASTICITY CHART

Plasticity of fine grained soil is estimated or determined from Atterberg Limit tests based on the plasticity chart on page 3.
